# REVISION OF DETAILED PROJECT REPORT FOR OM CHHU

Project:	Revision of Detailed Project Report for Omchhu
Title:	Final Report
Version:	2
Version Date:	June 2023
Author:	Hom Nath Adhikari, Rohit Adhikari, Purna Chhetri, Ugyen Lhendrup, Dorji Tshering, Indra Kumar Chhetri, Karma Gelay, Sangay Thinley, Devi Charan Dhimal, Roma Adhikari, Bikash Nepal

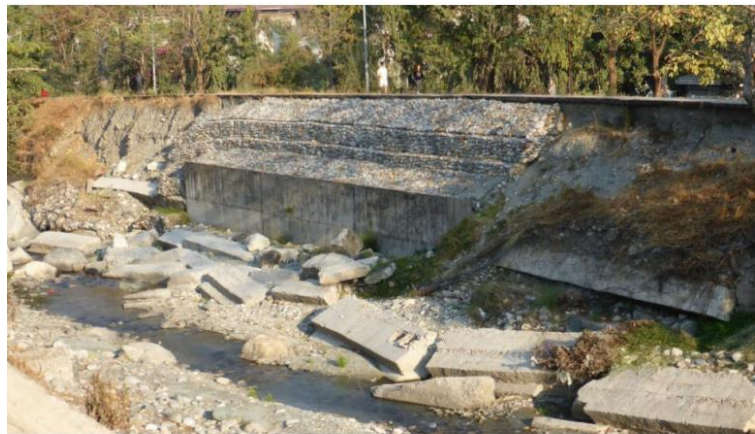
Figure 12: Omchhu embankment repairs following 2009 flooding

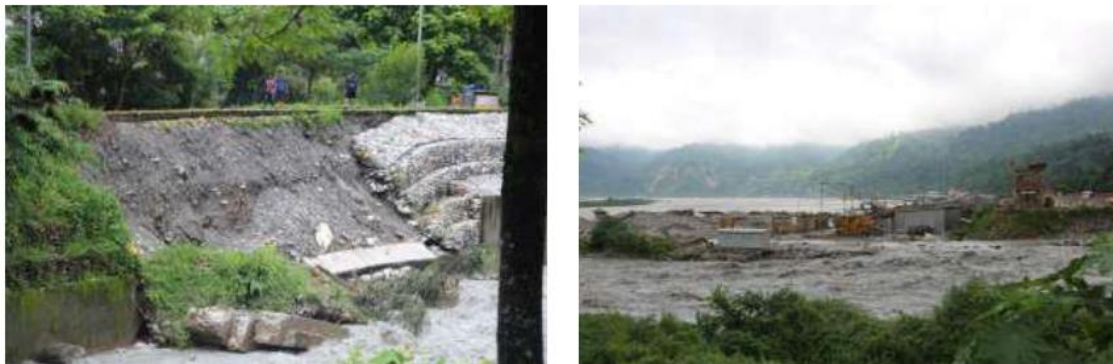
Figure 13: Damages caused by Dhoti Khola in 2016

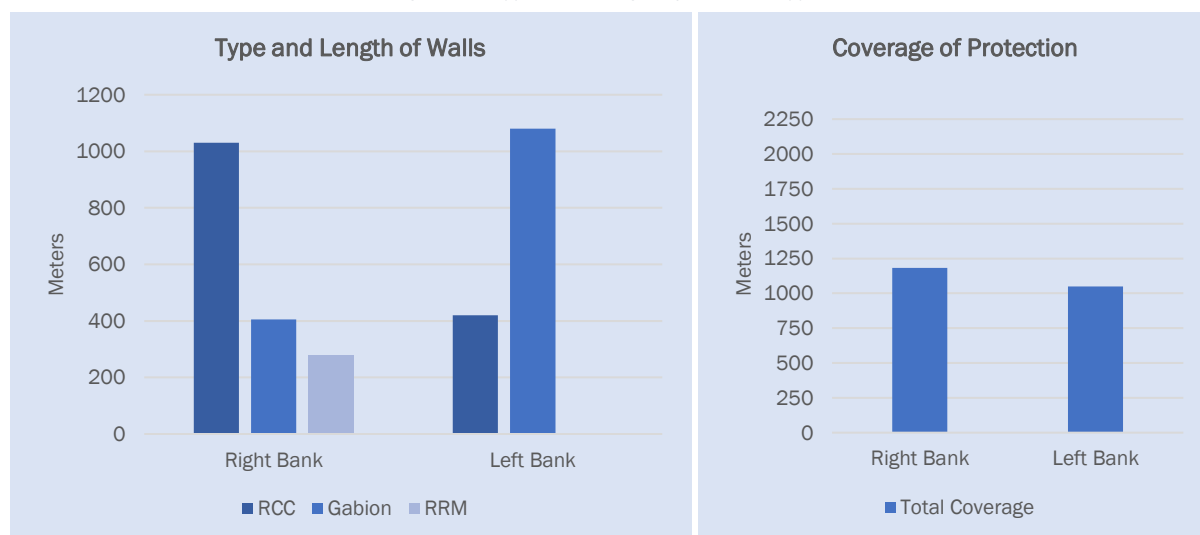
Figure 17: Types and Length of the Wall Types

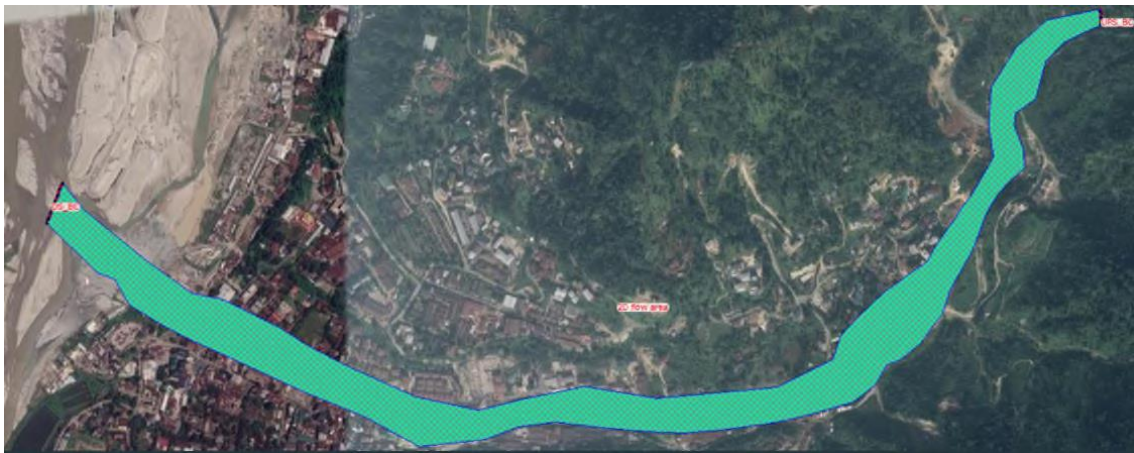
Figure 45: 2D mesh area

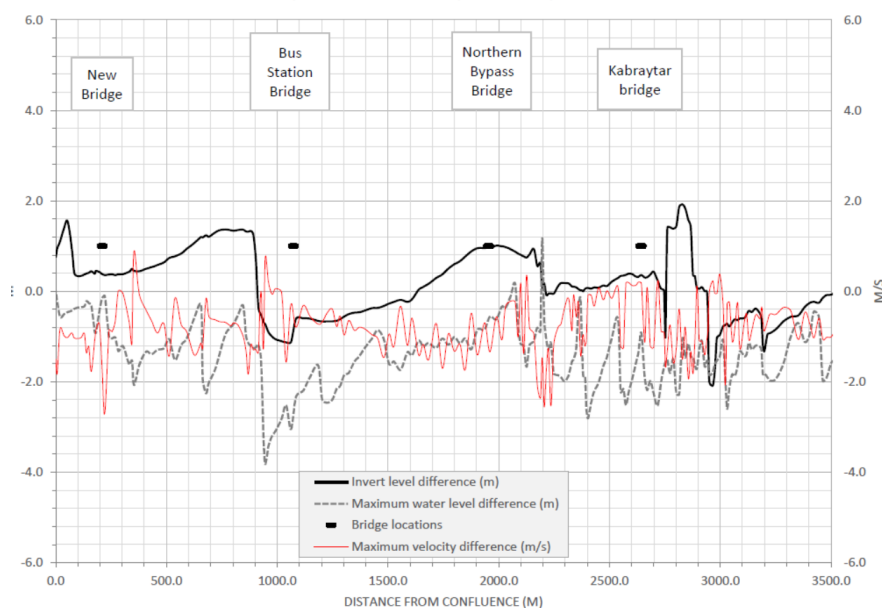
Figure 56: Impact of a lower probable flood PF3 versus the reference flood PF4  
Relative effect probable flood (PF3-PF4) for situation 2020

As can be expected, the maximum stream velocities and maximum water surface levels are simulated lower with the PF3 probable flood than with the PF4 probable flood (reference case). From Figure 56 it can also be noted that the bed level change in the section from 900 m to the confluence with the Amochhu compared to the reference situation is on average 1 m higher. This seems to indicate that sedimentation in the downstream section is sensitive for the flood discharge rate: at lower maximum discharge rates, higher sedimentation is simulated.

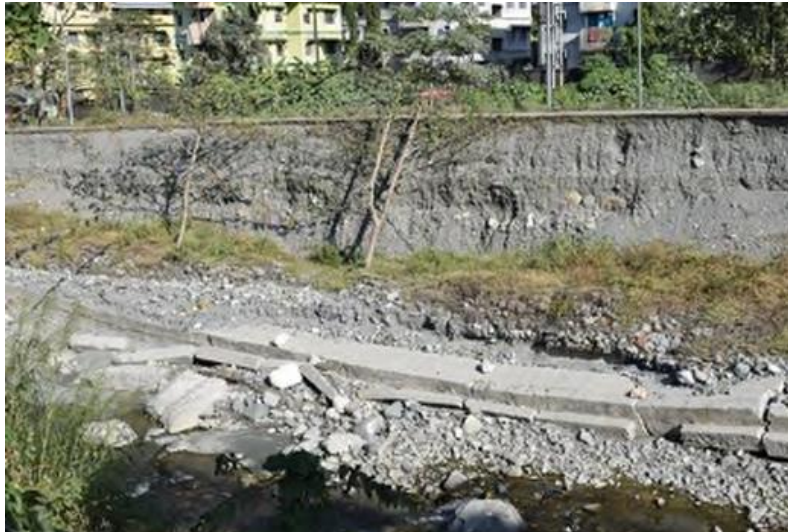
Figure 68: Armor on the banks of the Omchhu have failed in places. Photo taken in 2016.
